Number P.1
Section Electrical and Instruments
Sheet 1 (of 1)
Date January, 1960

INSTRUMENTS, OVERDRIVE AND AUTOMATIC TRANSMISSION INDICATOR LIGHTS

Mark 2 Models

JAGUAR SERVICE BULLETIN

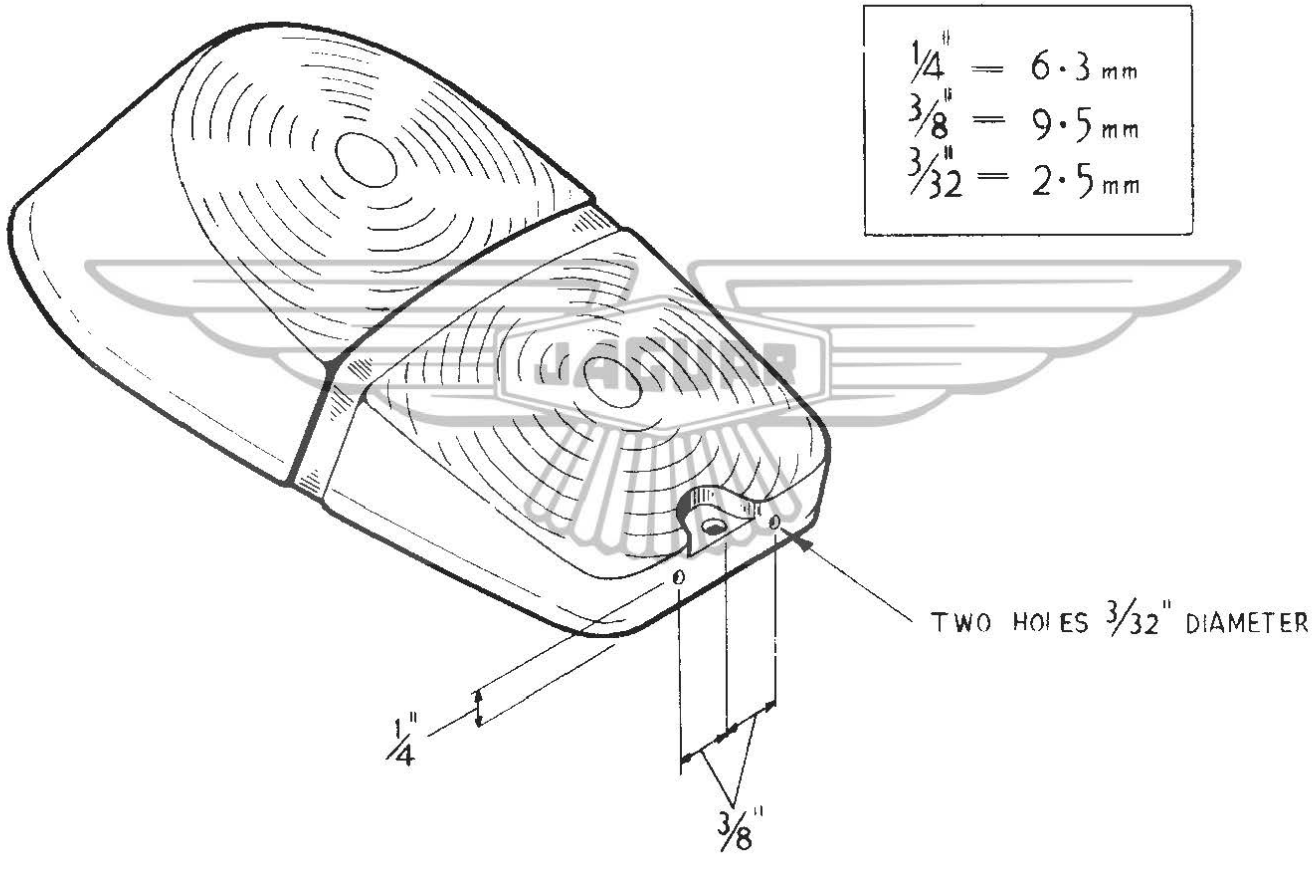
A certain number of 1960 cars with the new type rear lamps (with separate flasher and tail light bulbs) were sent out of the factory without the drain holes in the bottom of the lamp lens.

Cars in stock or cars coming in for servicing should be checked for having two holes drilled in the bottom of the rear lamp lens. If not so drilled, two holes should be made in the bottom of the lens as shown in the sketch overleaf.

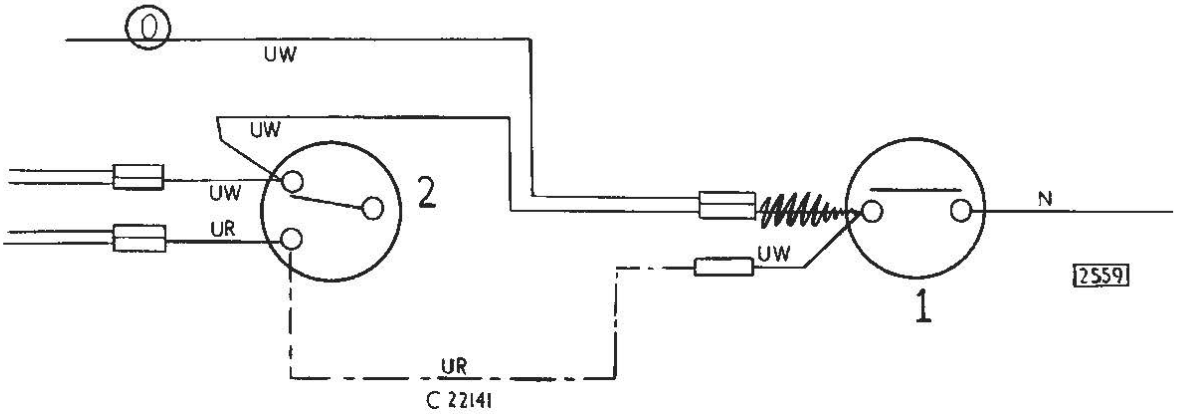
MK 2 MODELS

The amended wiring circuits are shown overleaf.

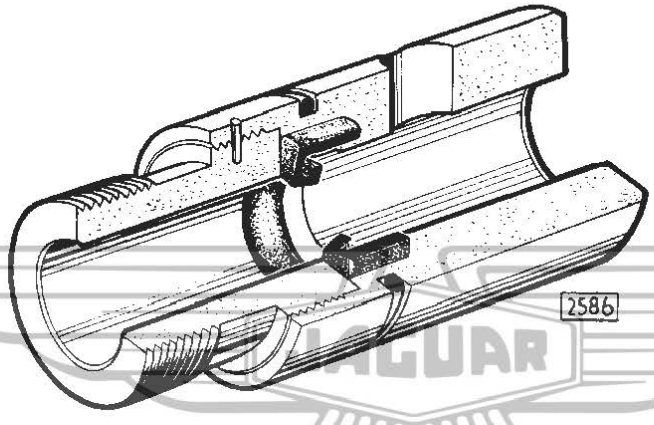
If oil is found to be working past the inner seal it will be necessary to dismantle the driven gear bush as follows:-

Screw the adaptor into the bearing and fit a new retaining pin. If necessary, drill a new 1/16" (1.5 mm) hole not more than 7/32" (5.5 mm) deep in the side of the bearing; fit a mild steel pin, peen over and file flush.

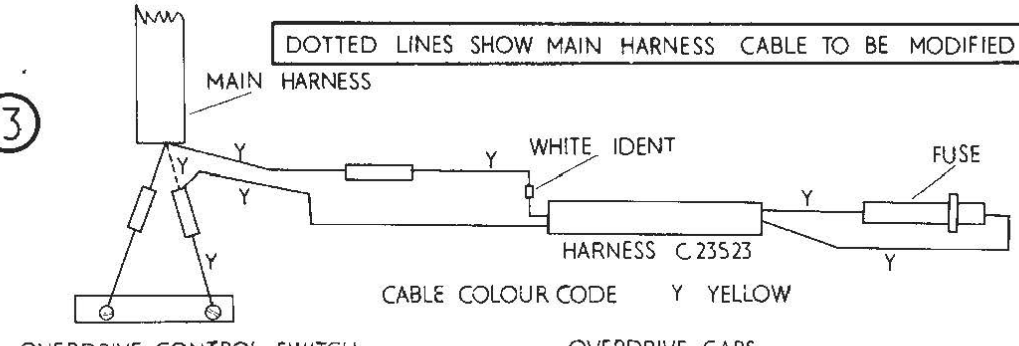
3

DOTTED LINES SHOW MAIN HARNESS CABLE TO BE MODIFIED

OVERDRIVE CARS

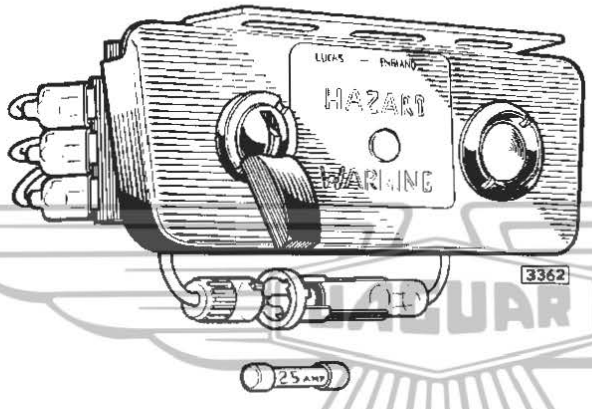
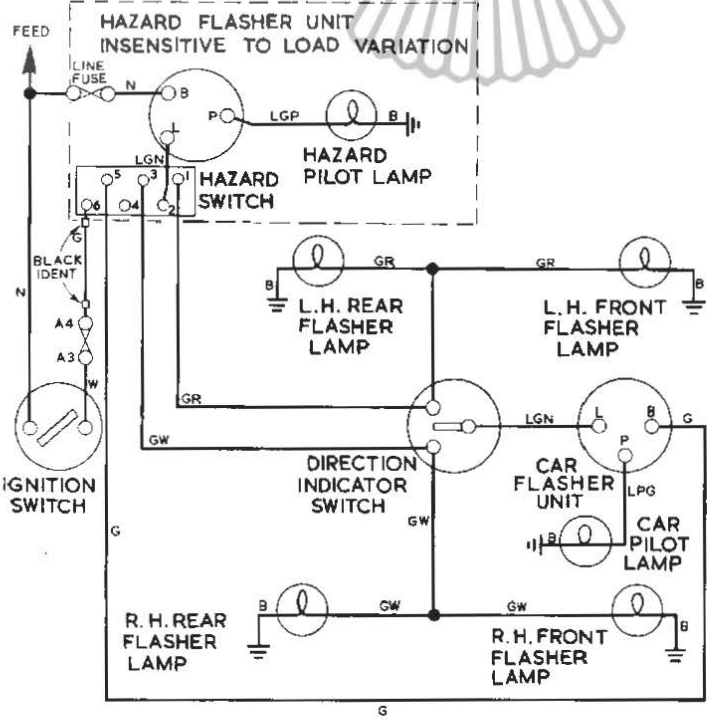
The system operates in conjunction with the four flashing turn indicator lamps fitted to the car and the operation of a toggle switch on a sub-panel will cause the four turn indicator lamps to flash simultaneously.

A red warning lamp is incorporated in the circuit to indicate that the hazard warning system is in operation. A 25 amp in-line fuse (14 amp American rating) is incorporated in the sub-panel circuit.

See illustration for circuit diagram.

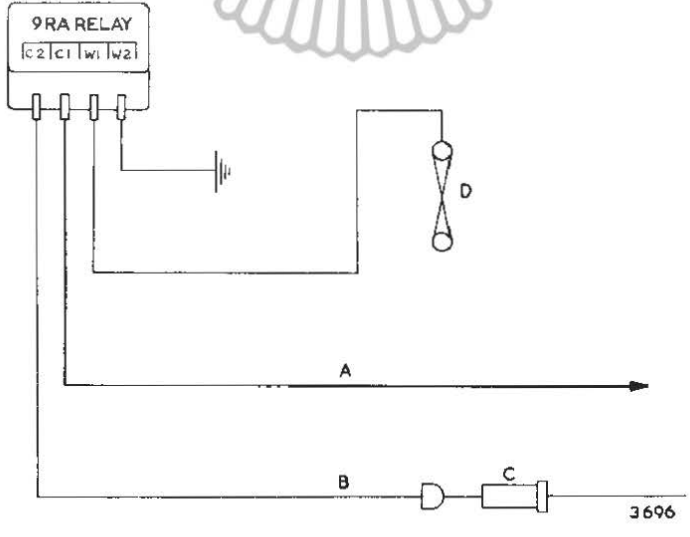
Isolated instances have occurred of ignition switch failure on cars fitted with an Air Conditioning System.

This has been traced to an excessive load being imposed on the two evaporator fan motors when operating under certain adverse conditions conducive to icing up, resulting in an overload on the ignition switch contacts and subsequent breakdown.

To prevent this fault recurring, a Lucas 9 RA Relay (Part No. C.19085) has been introduced into the Air Conditioning Electrical circuit on current production cars, the revised circuit being as illustrated.

If complaints are received of ignition switch failure, it is recommended that the relay is fitted in a convenient position and the circuit modified. The main output terminal (A) should have a 35 amp terminal fitted to connect to the alternator.
